# State of Utah DEPARTMENT OF NATURAL RESOURCES Division of Oil, Gas & Mining

## **Inspection Report**

Mine Name: Marblehead Mtn (South Pit & Process Plant)
Operator Name: Chemical Lime Company of AZ

Permit number: M0450024 Inspection Date: March 25, 2008

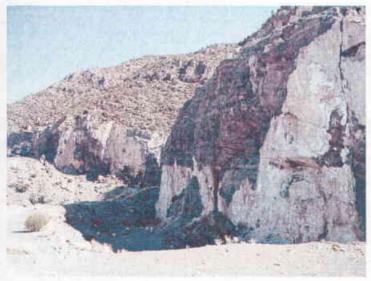
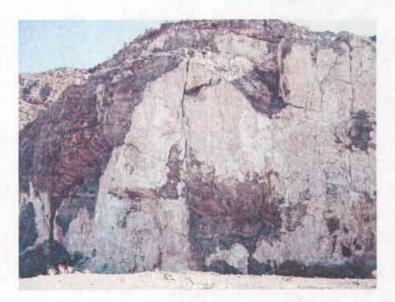
Photos taken 03-25-08

The quarry area appeared to have been in a state of inactivity for several years, with the exception that recreationalists (ATV's have been using the site extensively). While access is gated through the plant sight, there is unrestricted access to the South Marblehead pit that joins the quarry access road just below the quarry. There is highwall (both wedge failures and toppling rockfall) stability issues that should be addressed.

The access road between the plant and the quarry is showing eroding with small gullies developing. This needs to be corrected.

Access to the quarry area needs to be secured (blocked, gated, or ?) to prevent ATV access until the area is reclaimed. The access road between the plant and quarry needs to be maintained (or reclaimed along with the quarry area). If the plant is not going to be utilized in the near future, the operator should also consider reclaiming the plant site as well. The public safety is at risk related to some of the rockfall issues of the pit. Limiting access and rockfall devices (catchment berms, netting or?) should be addressed.
